RE: FOLLOW-UP TO 10/08/2015 SODIUM DICHROMATE SPILL AND NITRIC OXIDE RELEASE, NRC #1130443 AND #1130578

Tabulated Analytical Data for Soil Samples

Map of Sodium Chlorite Plant & Ditch Samples

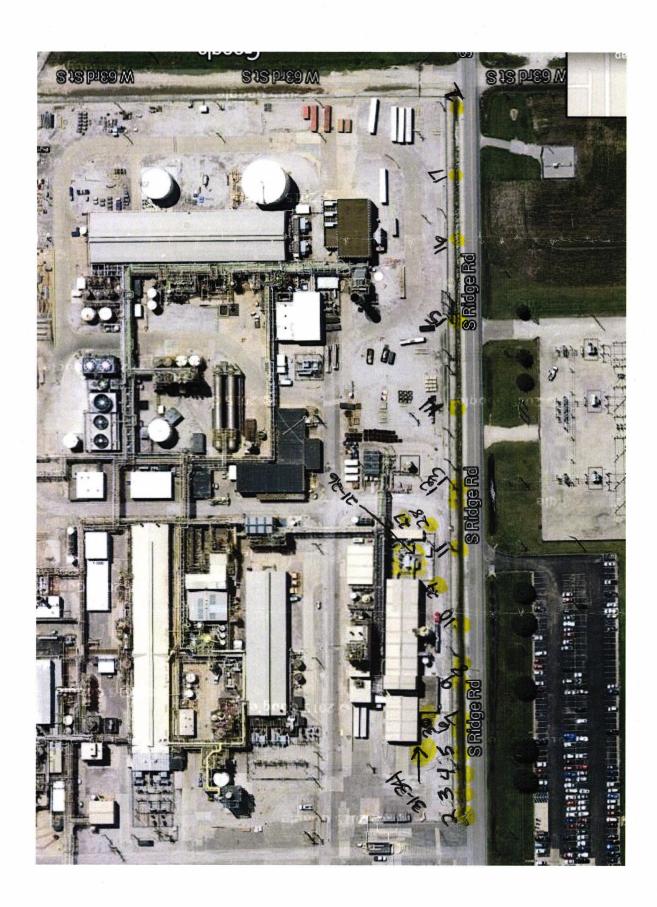
As requested please see the attached tabulated analytical and associated map for the soil samples that were taken as part of the clean-up of the sodium dichromate spill that occurred on October 8, 2015. The table represents 34 samples that were taken in the ditch adjacent to the facility and the samples surrounding the sodium chlorite plant inside the fence line. The ditch samples were compared to the residential standard of 33.6 ppm and the on-site samples within the fence line were compared to the industrial standard of 111 ppm. The map is of the sodium chlorite plant itself and the entire length of the ditch. The numbers on the map directly correlate with the soil samples. In the smaller areas where several samples were taken, the correlating numbers are grouped together.
